The Incision of the Riverbed on the Upper Hungarian Danube and the Rába, in the Region of the Confluence of the Moson-Danube

Keywords: hydrology, hydromorphology, trend analysis, flood protection, navigation, river basin, Danube, Rába, riverbed incision

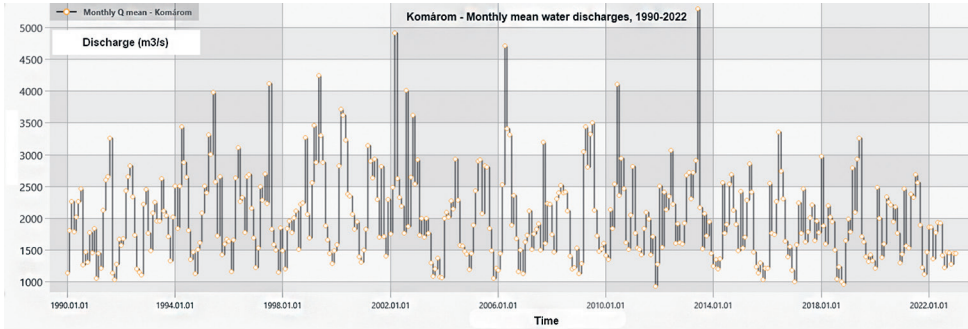
Figure 3: Discharge time series, Danube, Komárom GS
Source: General Directorate of Water Management (OVF) 2023

The reach analysed in our study extends from the gauging station of Devín (1,875 rkm) to the gauging station (GS) of Komárom (1,768.30 rkm).¹³ The catchment area of the Komárom GS is 150,820 km². The multi-annual mean discharge increases from 1,850 m³/s to 2,100 m³/s along this reach.¹⁴ The monthly averages of the discharges at Komárom over the last 30 years are shown in Figure 2.

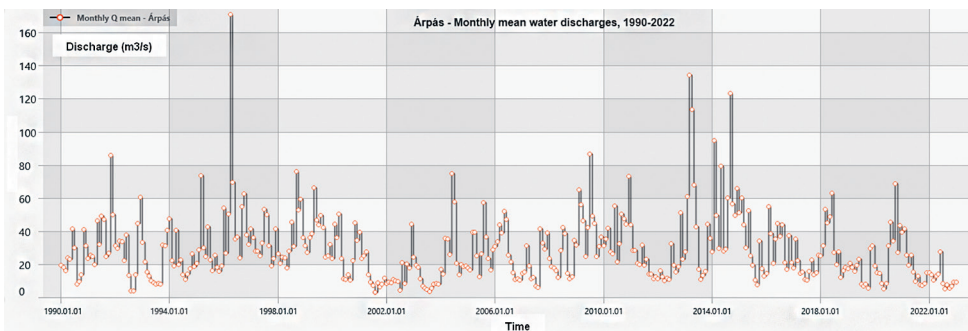
Figure 4: Discharge time series, Rába, Árpás GS
Source: General Directorate of Water Management (OVF) 2023

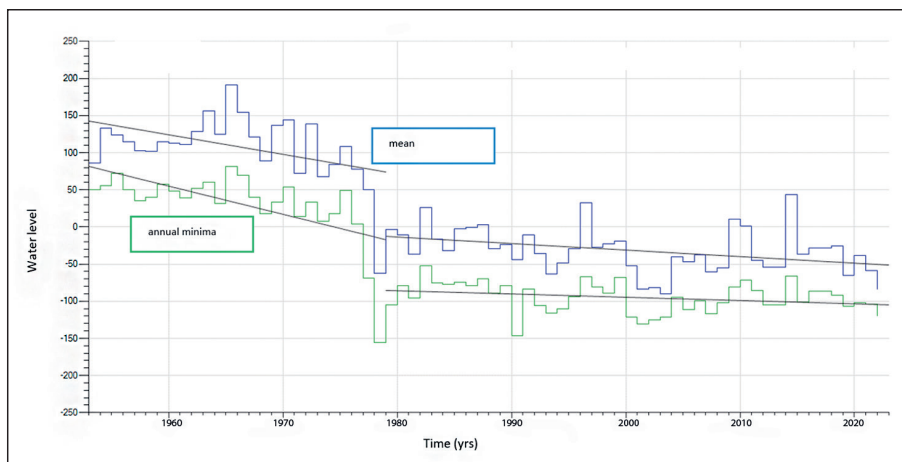
Figure 8: Water level trend analysis, Árpás GS, 1953–2022

The same phenomena can be observed on the Rába at Árpás GS.

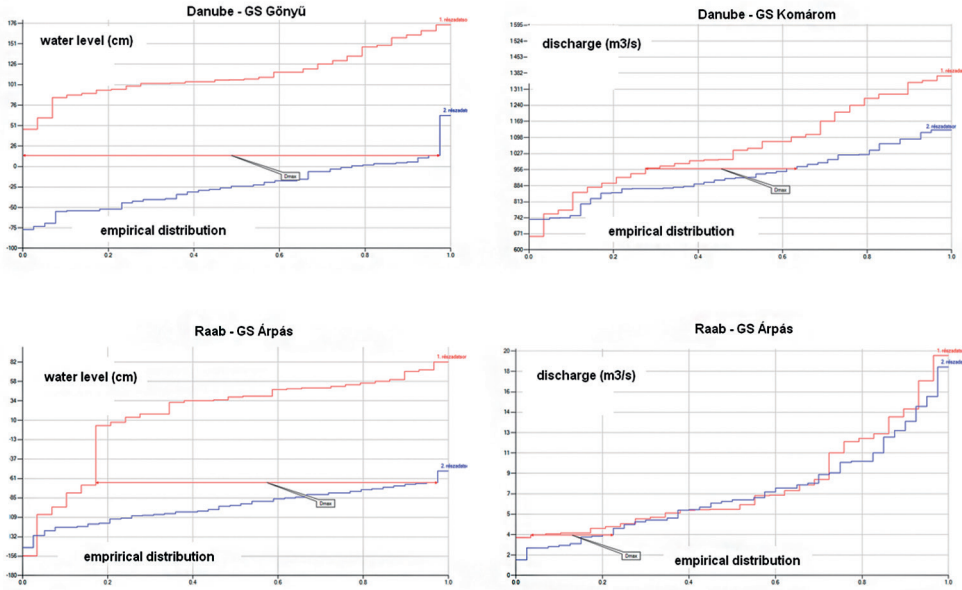
Figure 10: Kolmogorov–Smirnov homogeneity tests, Gönyű, Komárom, Árpás GS
Source: ÉDUVIZIG 2023

Homogeneity tests were also performed on the statistical sample of the hydrologic time series. The results of the Kolmogorov–Smirnov tests are shown in the next Figure (Figure 10). The different behaviour of the empirical distribution functions in case of water levels and discharges shows the effect of riverbed incision.

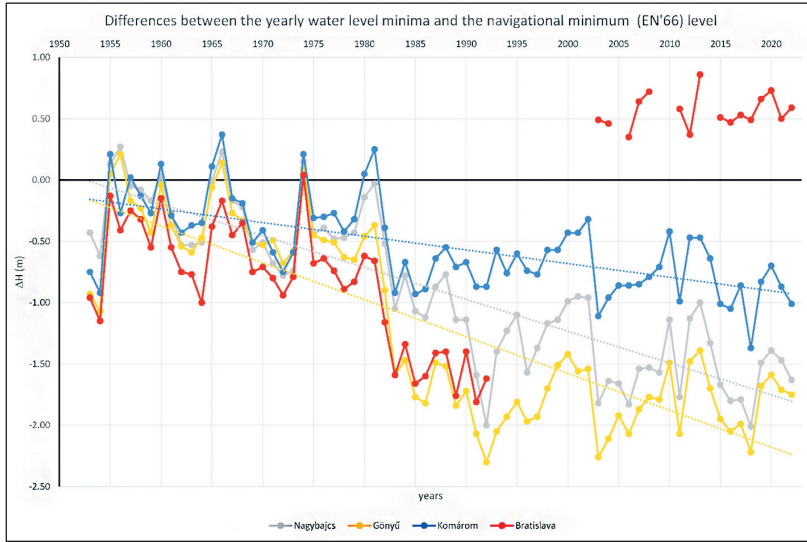
Figure 11: Water level differences compared to EN'66, 1953–2022

In the following figure, the time series of the annual minimum water levels for each gauge and the characteristic data series of the annual average of the monthly minima are plotted against the 1966 navigation low water level (Étiage navigable – EN) as a reference level.

The upper figure shows the deviation of the annual minimum water levels compared to EN'66. This figure also shows the significant effects of the dredging operations in the 1980s. The lower figure shows the time series of annual averages of monthly minimum water levels, which do not show significant short-term changes, but the trend indicates a clear bed subsidence, reflecting the impact of river regulation and channelisation that were performed upstream.

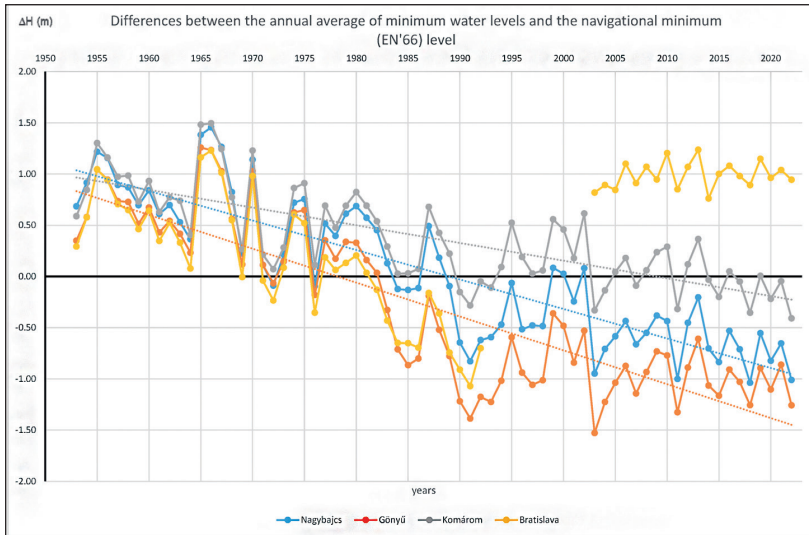
Figure 12: Water level differences compared to EN'66, 1953–2022

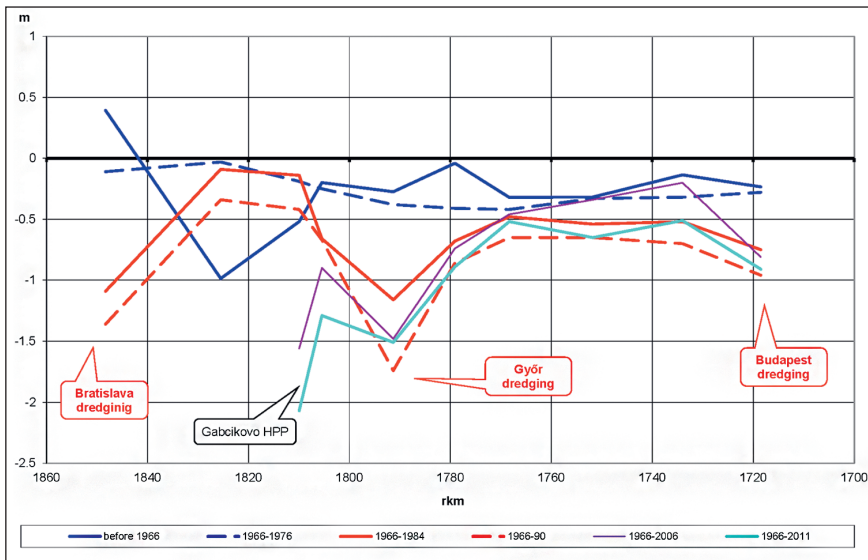
Figure 13: Longitudinal sections of water level differences compared to EN'66, 1966–2011

The longitudinal changes of this difference is shown in Figure 13 for different time periods. It can be seen that the deepening of the riverbed reaches almost 2 metres at the confluence of the Moson-Danube.

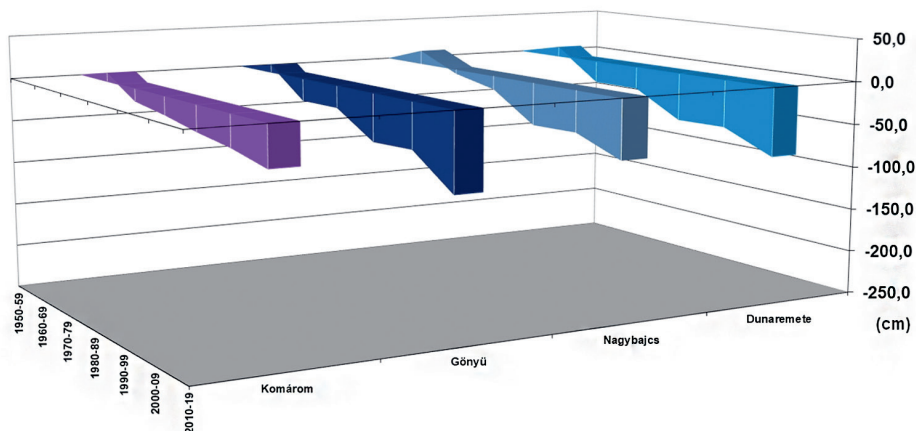
Figure 14: Integrated effect of riverbed incision and long-term changes of low water discharges on the Danube between 1950 and 2019

The following graphs show the variation of annual minimum water levels at each GS on the Danube and the Rába over the past 70 years, based on 10-years intervals averaging as in Tamás et al. 2021. As suggested by Kalocsa and Zsuffa in their publication (1997), the decrease is shown compared to the first year of investigation, i.e. the minimum water level observed in 1950 is zero on the vertical axis. The decrease which was concluded in 1997 continued at Komárom, Nagybjacs and Gönyű stations, and the increase that was reported for the period between 1901–1990 for the Dunaremete GS has reversed and now this station shows a decrease, too.

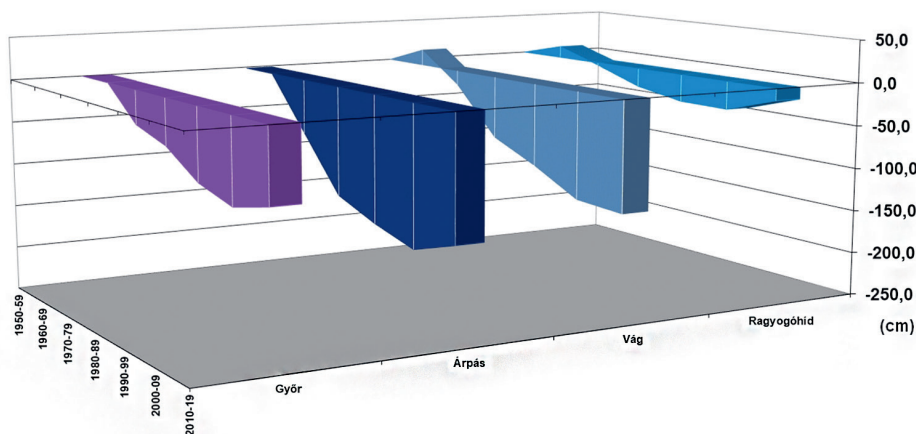
Figure 15: Integrated effect of riverbed incision and long-term changes of low water discharges on the Rába between 1950 and 2019

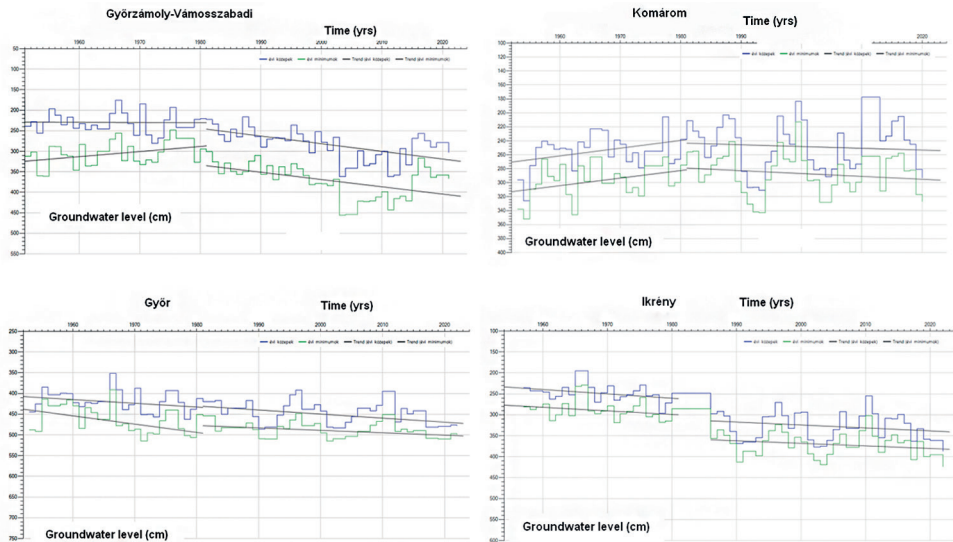
Figure 16: Groundwater trend analysis, 1953–2022
Source: ÉDUVIZIG 2023

A secondary consequence of the deepening of the riverbed is the depression of groundwater levels in the area. In the section of the Danube between Szap (where the tailrace of the Gabčíkovo HPP joins the Danube) and Gönyű, where the incision of the bed is most significant, groundwater levels have also shown a significant decreasing trend in the decades since the measurements started. In Győr area, this has been more than 1 m over the last 60 years. The phenomenon is illustrated by linear trend graphs of some monitoring wells in the area.

Along the estuary of the Rába, the groundwater level is decreasing by more than 1.5 m due to the Danube's incision. At Komárom, at the lower part of the analysed Danube section, there is a slight, but detectable decrease in groundwater levels.

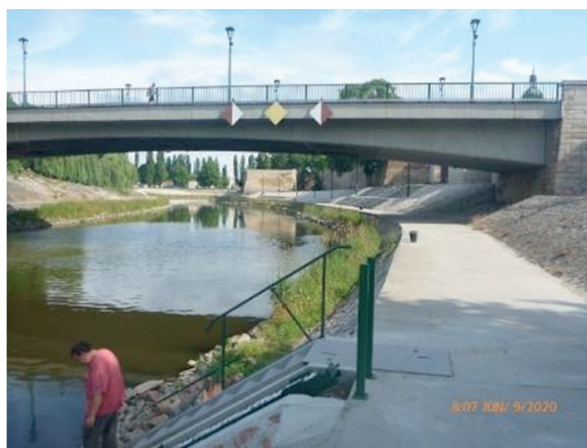
Figure 18: Low water level in Győr at the Rába gauging station

The phenomenon of riverbed incision is harmful to public health, makes water transport difficult, is not aesthetically pleasing and detracts from Győr's urban image. A typical low-water cityscape of Győr is shown in Figure 18.

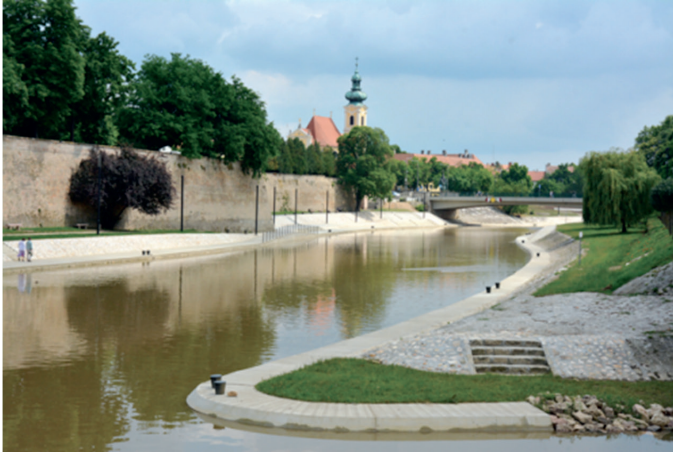
Figure 19: Water level rehabilitation in the city of Győr at the Rába estuary
Source: ÉDUVIZIG 2023

As a result of this operation seasonally a quasi-permanent water regime can be observed in the city of Győr, as it can be seen in Figure 19.
