Flood Protection Phenomena in the Körös Region

Since the regulation of the Körös Rivers, and following the construction of the flood protection systems and their development, several phenomena have developed on the embankments as a consequence of the receding flood waves. The following article presents the phenomena developed on the flood protection lines and flood control structures of the Körös Rivers. This information was collected, structured and categorised to better assess the flood protection lines. With the collected data, as well as with data from other sources (such as geomechanics, modelling) recommendations can be made on where and what kind of investment should be made in order to increase flood protection safety.

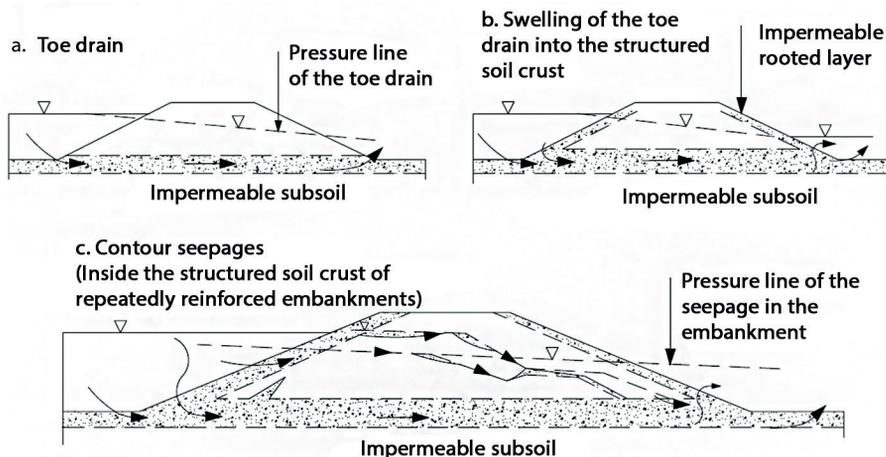
Figure 2: Seepage in heterogeneous embankments

that the inside of the embankments is almost without exception of heterogeneous nature. According to measurements made during flooding, considering seepage, the heterogeneity of embankments may occur in three forms: Seepage in heterogeneous embankments (Figure 2); Seepage in the subsoil (Figure 3); Complex seepages in heterogeneous embankments and subsoil (Figure 4).⁴

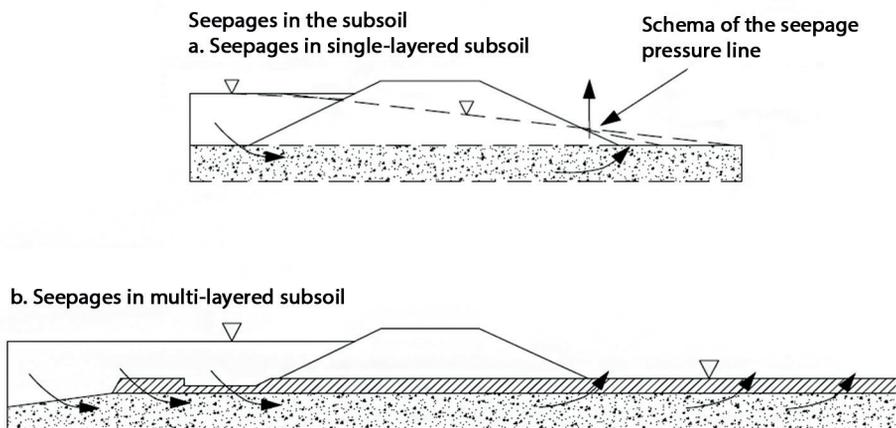
Figure 3: Seepage in the subsoil
Source: GALLI 1976

From the perspective of seepages, a multi-layered subsoil is also considered a naturally impermeable subsoil given that its bound top soil is so thick that the hydraulic soil failure on the protected side as well as the seepages under the embankments regarding the underseepage are negligible. Seepages may occur both in embankments and in the subsoil.⁵

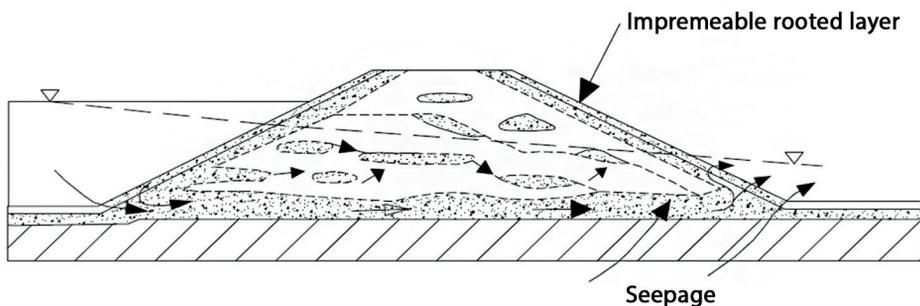
Figure 4: Complex seepages in heterogeneous embankments and subsoil
Source: GALLI 1976

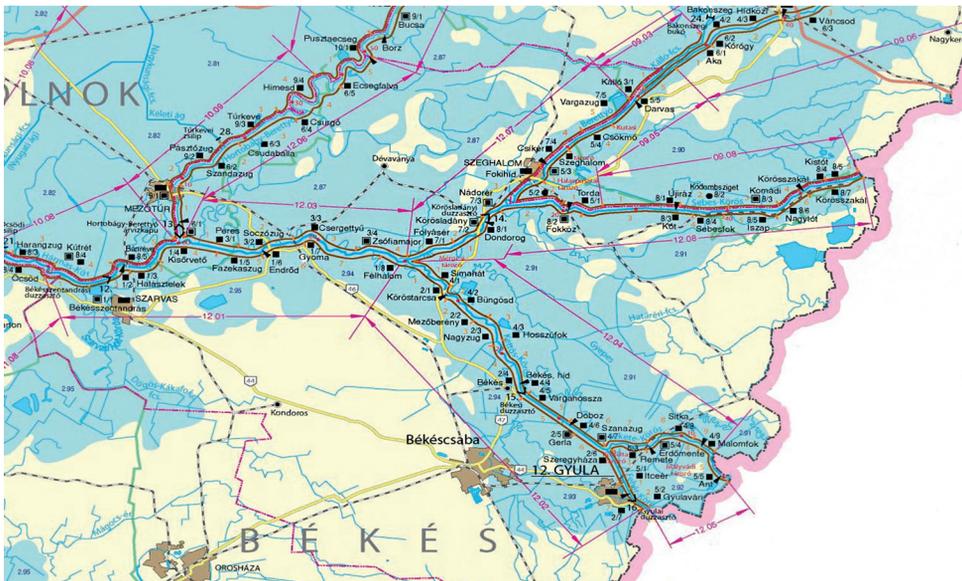
Figure 5: Flood protection system of the Körös Region Water Management Directorate
Source: General Directorate of Water Management 2014

The flood protection settlements and areas in the Körös region are protected and exempted from floods by flood protection sections, including flood protection embankments (Figure 5).

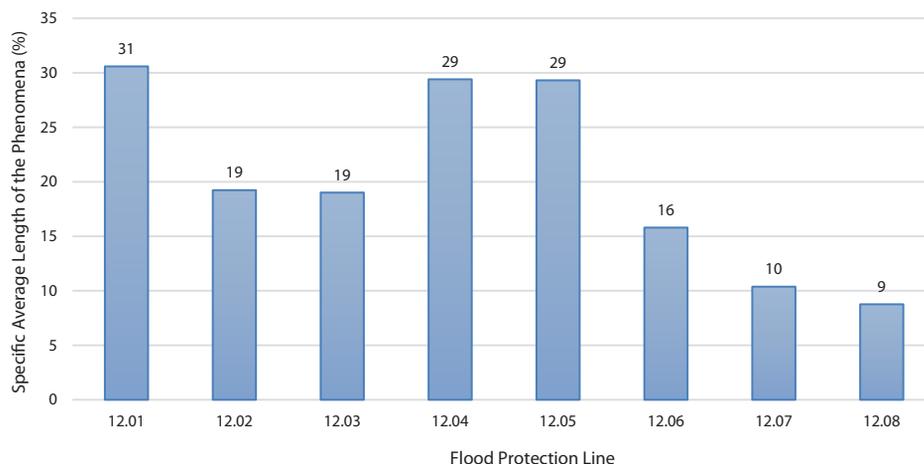
The following graph below shows the danger and load of the protection lines as the specific average length of the flood protection phenomena per protection line. The specific average length is the average of the length of the phenomena developed so far and the quotient of the length of the protection line, expressed in percentage.

Figure 6: The specific average length of the phenomena occurring at the protection lines (%)

As shown in the chart (Figure 6), considering the already occurred phenomena, the protection line 12.01, i.e. the Hármás-Körös section is the most overloaded with its specific average length of 31%. This is followed by the 12.04 line of the Kettős-Körös and the Fekete-Körös section with 29%, then the 12.05 line of the Fekete-Körös and Fehér-Körös section with 29%.

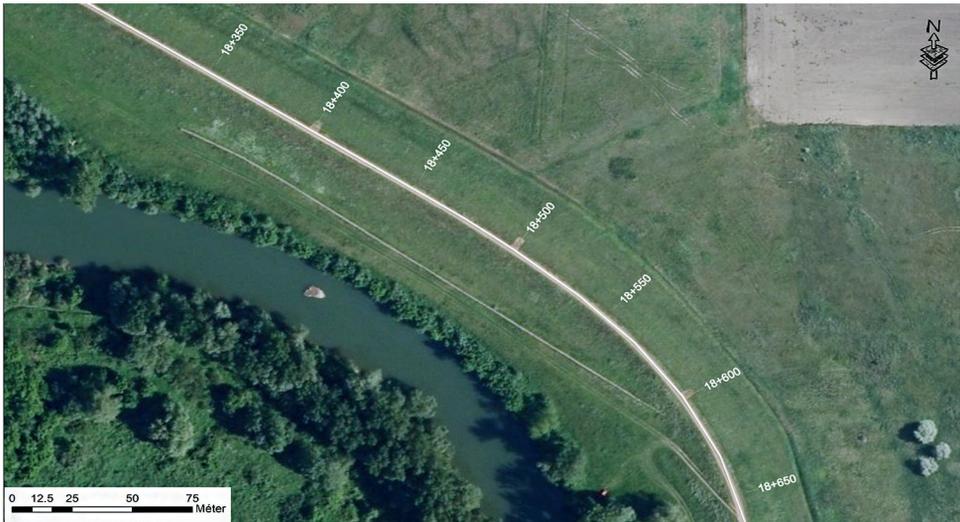
Figure 7: The right side of the embankment on the Kettős-Körös between 18 + 350 – 18 + 650 tkm
Source: compiled by the author

On the 12.04. flood protection line, the soil properties of the embankment can influence the number of phenomena occurred (average duration of floods is 21 days). Contemporary records already confirm that a significant number of seepages in the embankment and subsoil have been developed on this protection line due to the saline soil of the embankment. This is also confirmed by the fact that this was the first section where a brick wall (Figures 7 and 8) was built into the embankment as a protection against seepage.

The following figures show the current status of the exposed brick wall that was uncovered during the fixing of the embankment (Figures 7 and 8).

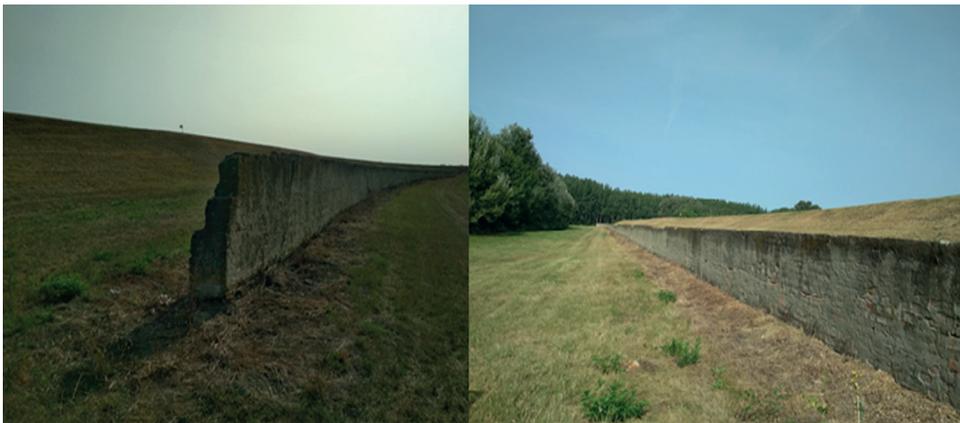
Figure 8: The right side of the embankment on the Kettős-Körös between 18 + 350 – 18 + 600 tkm
with the exposed brick wall
Source: compiled by the author

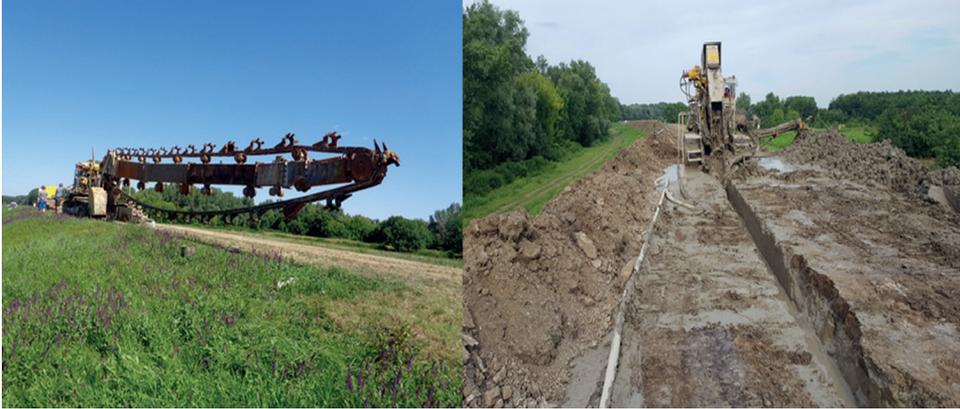
When creating (Figure 9) a self-hardening slurry wall, a rift is made with a scraper chain in which the binding agent is delivered into the different depths of the planned slurry wall either by gravity or by injection. It is then mixed with the soil and solidifies into a self-hardening slurry wall. This type of wall helps preventing seepage.

Figure 9: Building a slurry wall on the embankments of the Hármas-Körös
Source: Körös Region Water Management Directorate

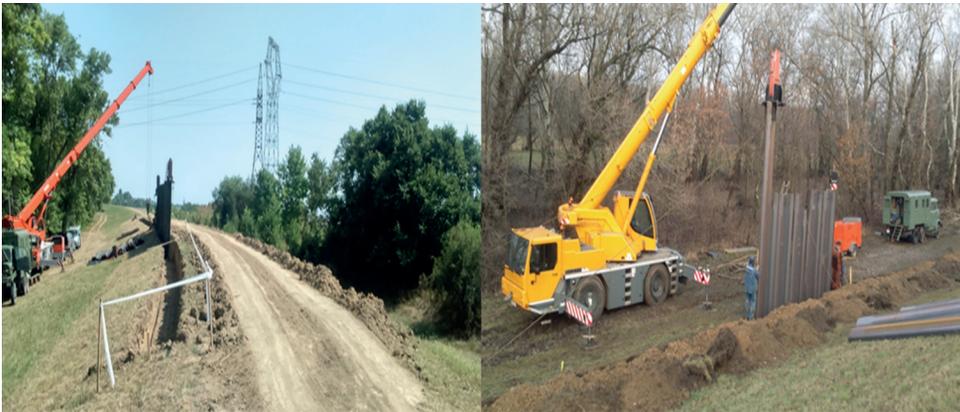
The sheet pile walls – put down with hydraulic sheet piler one after another – prevent water seepage both in the embankment and the subsoil (Figure 10).

Figure 10: Construction of the sheet pile wall at the toe of the dyke and embankment of the Hortobágy-Berettyó river system
Source: Körös Region Water Management Directorate

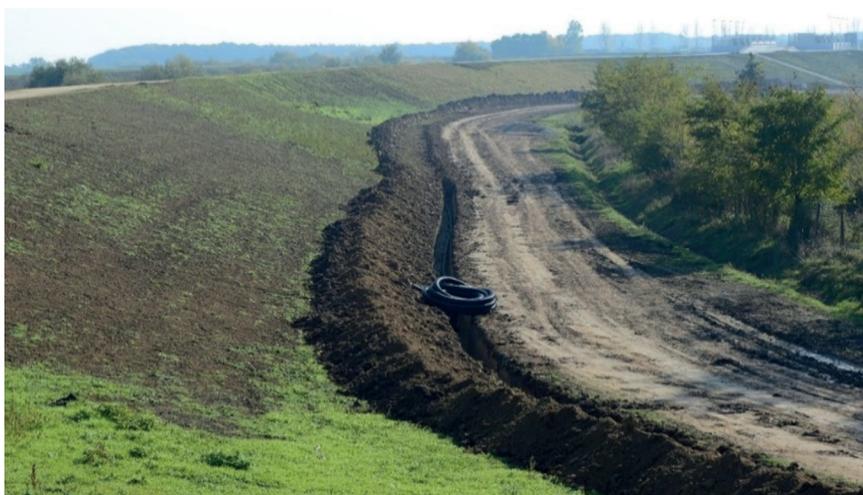
The drainage system is a method of active protection against seepage, which collects the water leaking through the embankments at the toe of the dyke on the protected side of the embankment. The water is then directed into the seepage canal.

When the purpose of the system is to drain the water out of the subsoil, the structure is called a gallery (Figure 11).

Figure 11: Construction of a drainage system at the toe of the dyke on the protected side of the embankment on the Fekete-Körös river

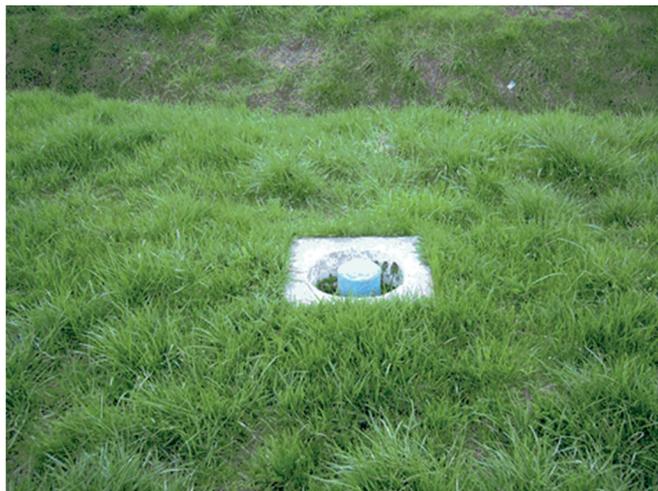
A pressure relief well (Figure 12) is a protected side tapping system that lowers the seepage pressure loss line by removing water seeping through the subsoil due to flood column pressure, thereby reducing the buoyancy force on the protected side to a tolerable (non-hazardous) level and thus significantly reducing hydraulic fracturing.

Figure 12: Relief well at the protected side forehead on the Fehér-Körös river
